ARL-AERO-PROP-TM-440

Aero Propulsion Technical Memorandum 440

**AN INVESTIGATION INTO LOW FUEL PRESSURE WARNINGS  
ON A MACCHI-VIPER AIRCRAFT (U)**

by  
D.E. Glenny

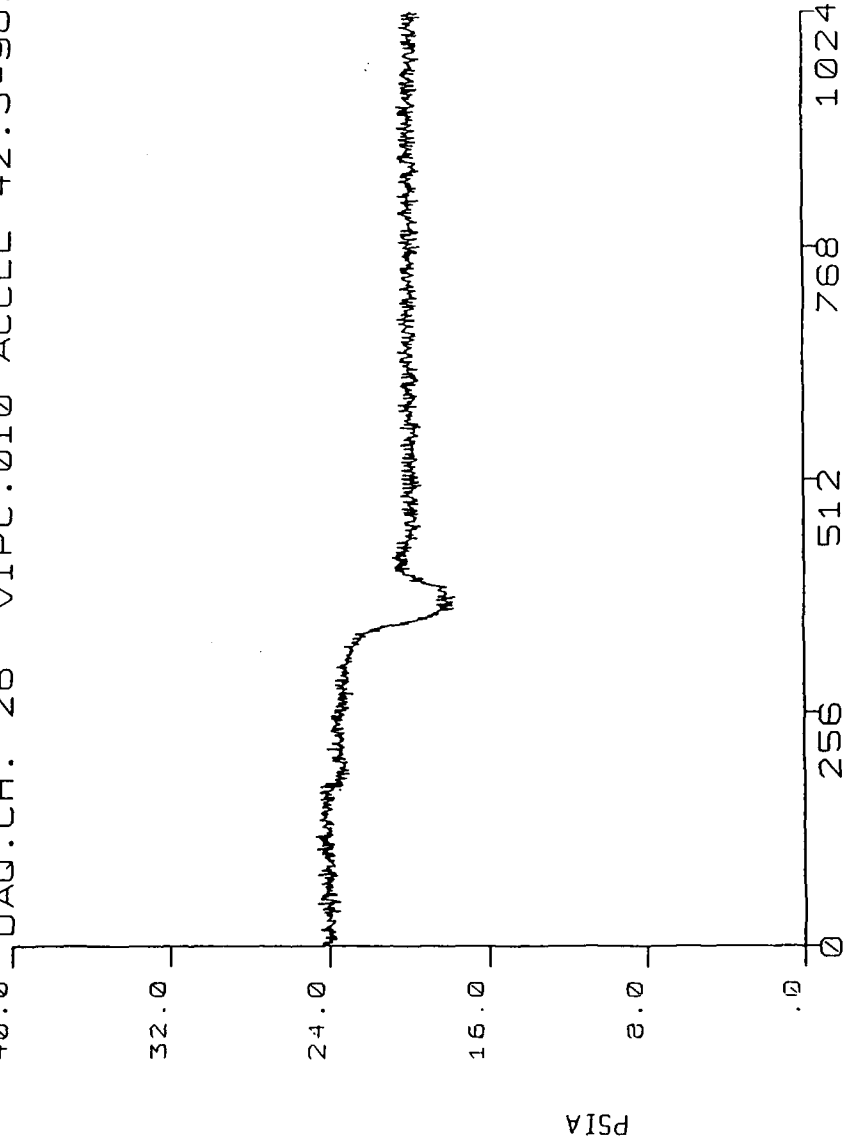
FIGURE 3

An analysis of the data acquired from block VIPC.010 indicates that the minimum pressure level as recorded by the transducer located downstream of the fuel filter was 17.3 psia or 2.6 psig. The level as indicated in Figure 3 occurred during the transient or acceleration phase, and was sufficient to activate the low pressure warning light. The pressure switch is normally set to a differential of between 2.5 - 3 psi. Partial illumination\* of the light is indicated in Figure 4. More definite results for light illumination will be seen later in the analysis of the rough handling tests. The effect of the HPFP in "sucking down" or reducing pressure levels in the low pressure fuel line, especially during the acceleration phase, can be seen in Figures 5, 6 and 7 for different locations in fuel supply line. An "impulsive" drop in pressure of the order of 6 psig from the steady state idle values (or 2 psig below the final steady state value) is readily apparent. The pressure level then rises to a level consistent with operation at maximum engine speed. It is this transient reduction in low fuel pressure levels that is responsible for the warning light illumination, and not operation at any given steady state engine speed. The fuel flow response, consistent with the output from the HPFP, is given by the traces of Figure 8. The signal, at low fuel flow rates, exhibits considerable noise due to the low frequency signal from the turbine impeller. Unfortunately the engine speed signal was incorrectly connected and no records were available. From Figures 3, 5 and 6 it is immediately apparent that the delivery pressure from the low pressure boost pump is low. At an engine speed of 42.5% with minimum demand from the HPFP the level is about 24.7 psia or 10 psig; it is not known, at this stage, what minimum acceptance value is specified in the maintenance manual. It should be noted that overall pressure levels in the low pressure line are dependent, not only on the boost pump performance and pressure drops in the fuel pipes and filter but are also dependent on the suction demand imposed by HPFP during acceleration, or transient operation. The steady state suction values are highly dependent upon engine speed; at 100% the low fuel pressure level is 19.8 psia or 5.1 psig, just on the limit recommended in the maintenance manual. Operation in this condition gives only a 2.1 psig margin for light illumination, if the pressure switch is set at 3 psig, and gives little scope for extra pipe or filter losses when the suction demand or depression from the HPFH is imposed on the low pressure fuel system during rapid accelerations.

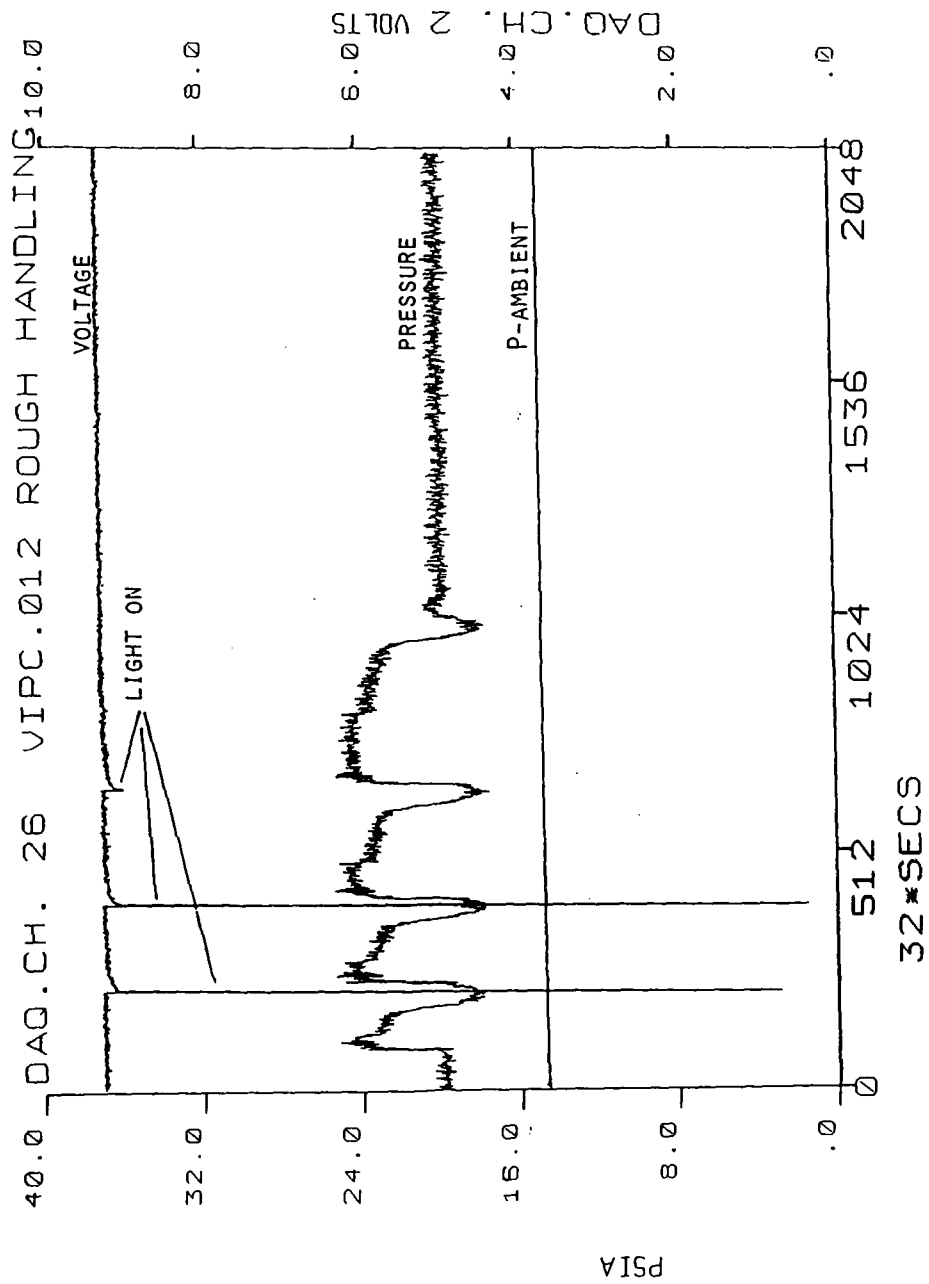
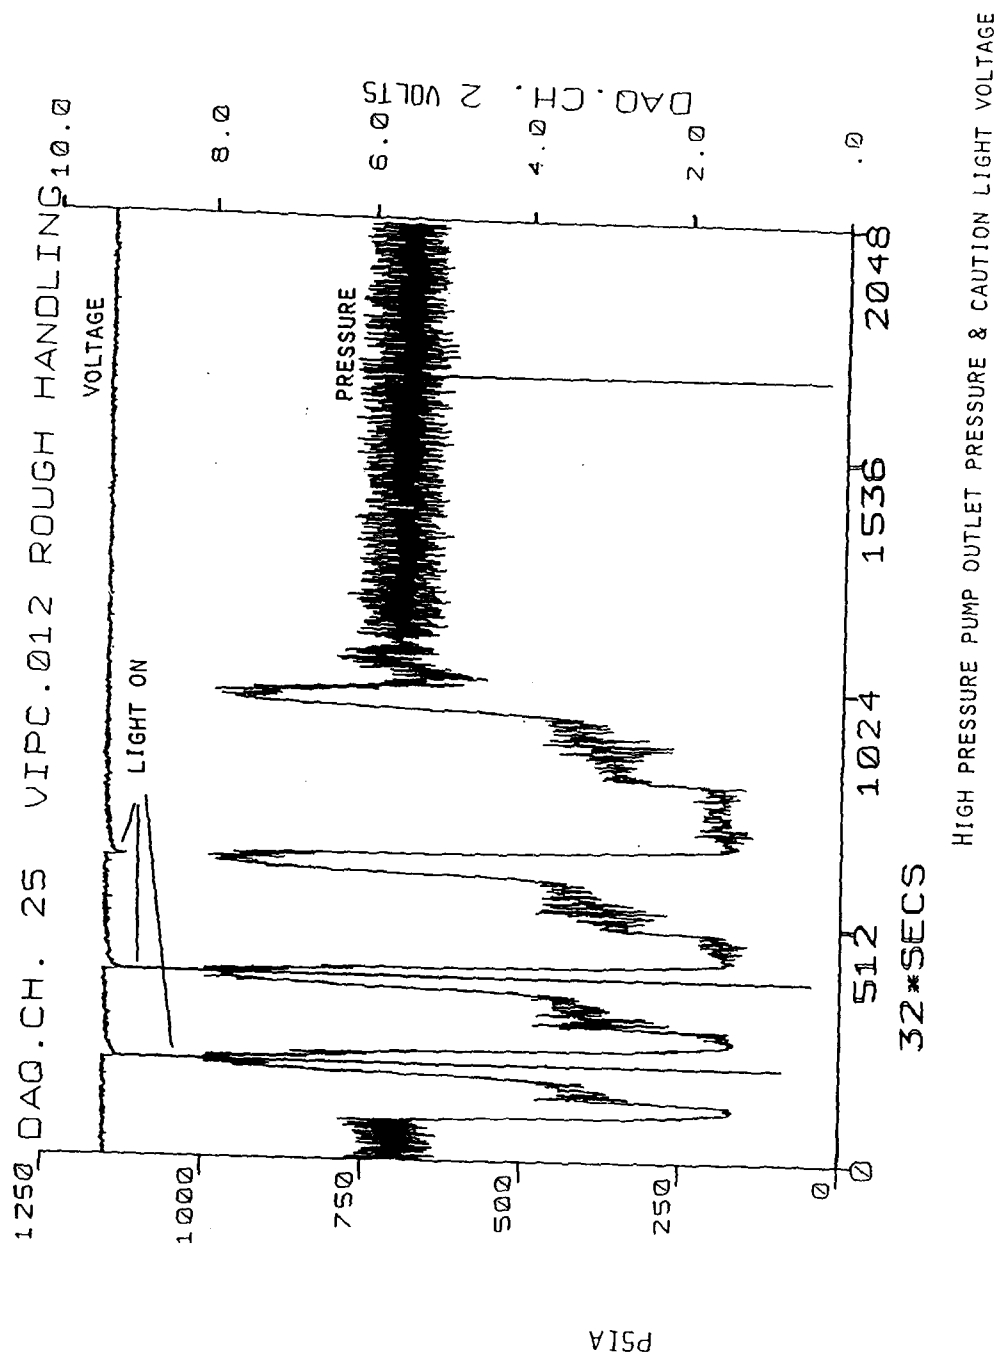
The performance of the low pressure fuel system can be seen more dramatically in the results for the rough handling tests. Composite pictures for fuel pressure levels after the filter and HPFP, light illumination and ambient pressure, are given in Figures 9 and 10. Immediately apparent are the small operating margins, 2.5 psig, under which the fuel system operates and the poor low pressure fuel pump performance on aircraft A7-097. There is also no doubt about the coincidence of light illumination and the low fuel pressure levels. Data output for the remaining channels recorded during the tests are given in Figures 11 - 15, Figures 13 and 14, in particular, indicate that the low fuel pressure warning light illumination is not

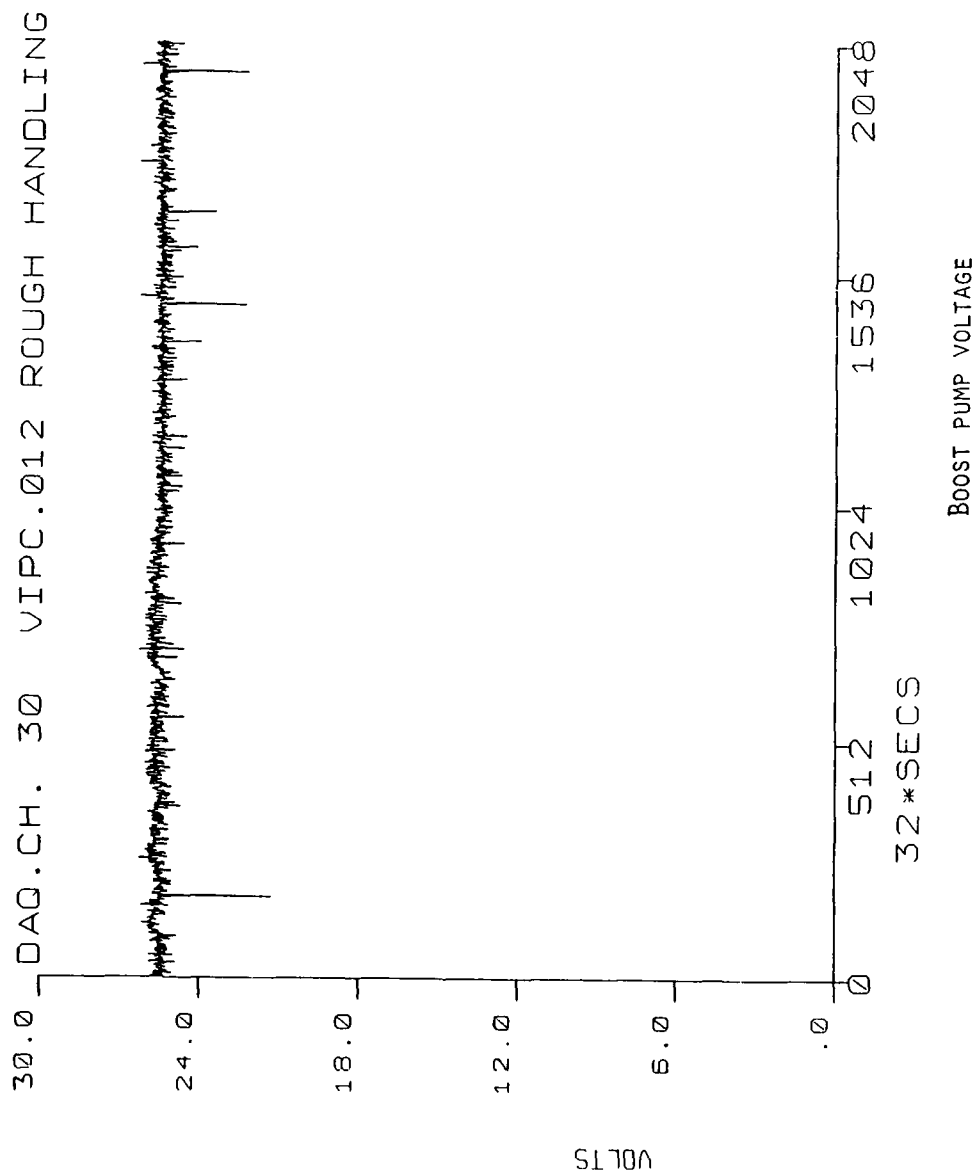
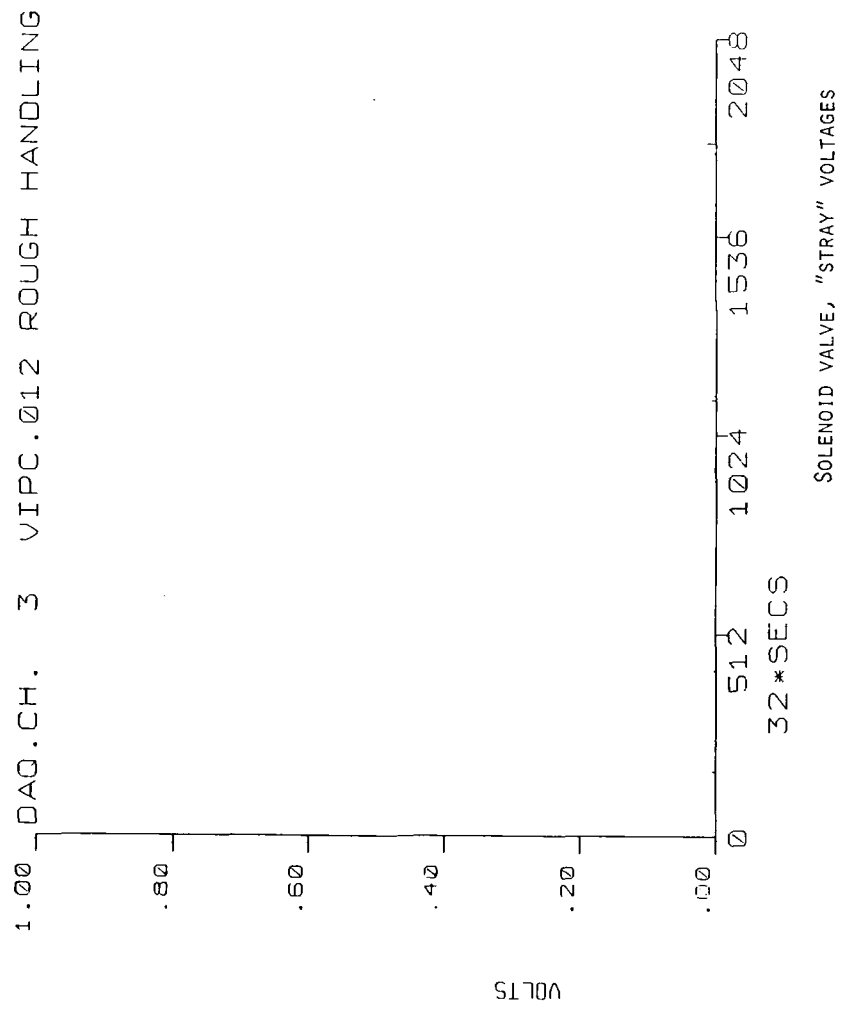
related to a variability in boost pump voltages, or stray voltages at the solenoid valve resulting in its unscheduled closing.

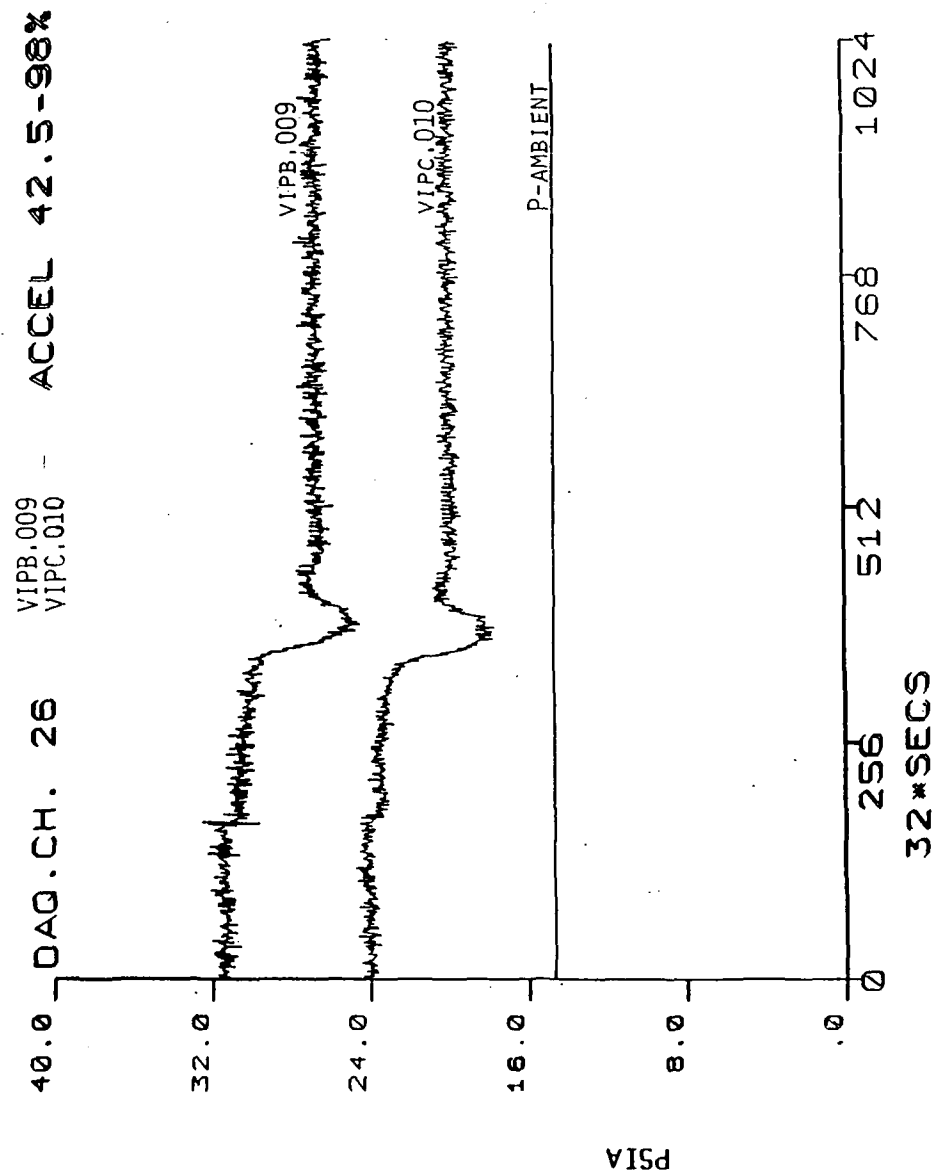
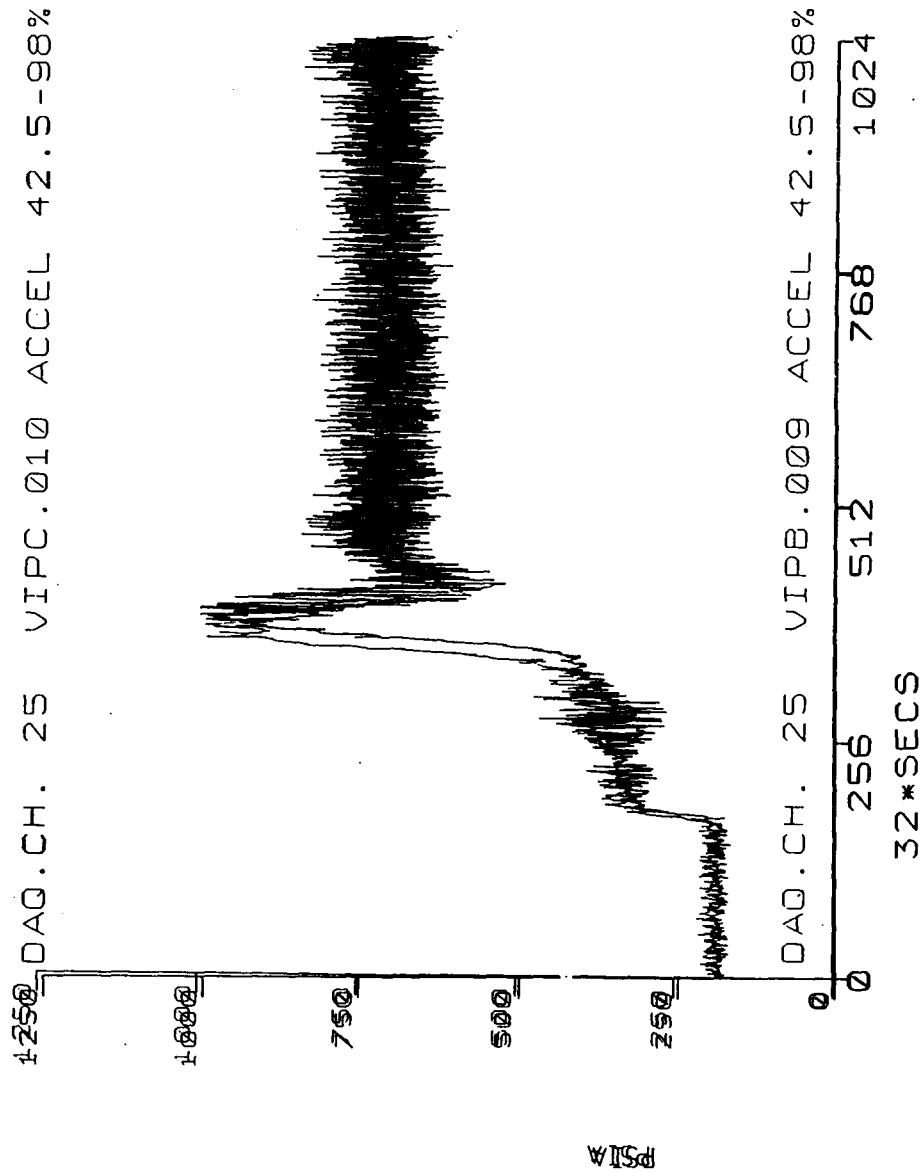
A direct comparison of the differences in the low pressure fuel system performance of aircraft A7-11 and A7-097 can be seen in Figures 16 and 17, in which a superposition of pressure levels after the filter and HPFP has been made for similar controlled accelerations. The difference in low pressure pump supply, and delivery levels after the filter for both aircraft, Figure 16, is self evident, whilst for all purposes the pressure drops across the filters are equal. There is little difference in the relative performances of the HPFPs, Figure 17, notwithstanding the different (low pressure) inlet conditions. There are however minor differences in signal to noise ratios and acceleration times for both sets of traces, but considering the relatively crude and hurried test procedures used, on the tarmac at RAAF Base East Sale, this was to be expected. A more direct comparison of data could have been made if a power level angle (throttle) position or rotor rpm record had been acquired. More specific performance characteristics of the aircraft fuel systems can be obtained by determining absolute pressure levels, and pressure drops in the fuel pipework, at stations 14, 1 and 26, for a range of engine speeds. Figures 18, 19 and 20 respectively gives examples of the raw data, for the fuel systems of both aircraft for the three nominated stations for an acceleration from 70% - 100%. Using these types of data traces, pressure levels at the beginning and end of each acceleration were determined by sampling up to 256 nominally steady state points (8 seconds of data) and calculating the signal mean  $\bar{x}$ , its standard deviation  $\sigma$  and the coefficient of variations CVA. Sample values of  $\bar{x}$ ,  $\sigma$  and CVA are presented in Table 3 for data in Figures 18 - 20. Using the steady state values of pressure,  $\bar{x}$ , system pressure levels and filter pressure drops were plotted as a function of engine speed. Figure 21 gives the pressure drop in the fuel piping and the low pressure filter, stations 14 - 1 and 1 - 26 respectively. As mentioned earlier there is a degree of uncertainty about these levels as they are differences between two numbers of similar magnitude. Notwithstanding the method of analysis the data and trends appear to be consistent. From the data it appears that there is little if any difference in pressure drops across the filter for both aircraft, with the pressure drop increasing from 0.2 psi to 0.65 psi as the "steady state" speed increases from idle to maximum. There is however a minor difference in pressure drops across the pipework from the solenoid valve to the filter. The ducting in Aircraft A7-097 (warning light illuminated) having an approximately 0.1 psi larger pressure drop: no explanation can be given for this difference. A comparison of the fuel boost pump pressure levels with engine speed (steady state) for both aircraft is given in Figure 22 at station 14, just after the solenoid valve. As indicated earlier in Section 4.1, the fuel boost pump pressures are consistently lower for aircraft A7-097 than for A7-011, a difference of at least 7 psi existing across the speed range. The absolute level for A7-011 is approximately 32 psia (17 psig) at idle and 28 psia (13 psig) at maximum engine speed: the values for aircraft A7-097 are 25 psia (10 psig) and 20 psia (5 psig) respectively. This later value gives only a 2 psig margin for suction pressures imposed by the HPFP during accelerations if the pressure switch is set between 2.5 - 3 psig. Any untoward pressure resistance in the fuel delivery line and filtering system would soon erode this margin, remembering that accelerations from any speed level can impose suction pressure drops of the order of 2 psig lower than the final steady state value: this would leave only a small margin for induced cavitation at the inlet of the HPFP.

An analysis of a series of engine tests carried out at RAAF Base East Sale on the fuel systems of two Macchi Jet Trainers has shown that the low pressure fuel system warning light illumination in Aircraft A7-097 was a direct consequence of poor fuel boost pump performance. There was up to a 7 psig difference in pressure levels between the two aircraft tested. Pressure drops in the fuel systems of both aircraft were similar with no difference being measured across the filters and only a minor variation (0.1 psig) being recorded in the ducting between the solenoid valve and the filter: aircraft A7-097 having the greater pressure drop.
